Manhole Inspection Summary

Manhole # S31SS1007MH

Location Address: **4701 N CHARLES ST**

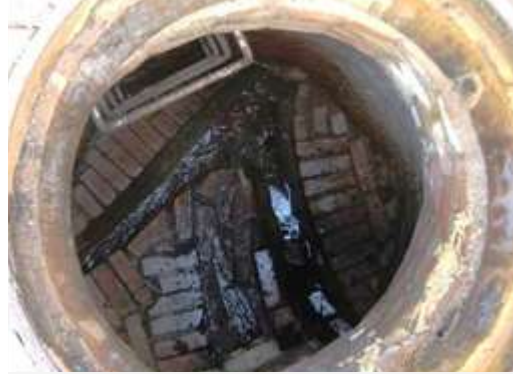
Top View

Offset: **1.5** (in.)

Condition: ☐ Sound ☐ Cracked ☐ Root Intrusion ☐ Loose Brick ☒ **Deteriorated**

Infiltration: ☐ None ☒ **Joint** ☐ Cracks ☒ **Mortar** ☐ Roots ☐ Wall

Frame offset. Adjustment deterioration and infiltration. Bench and Channel cebris.

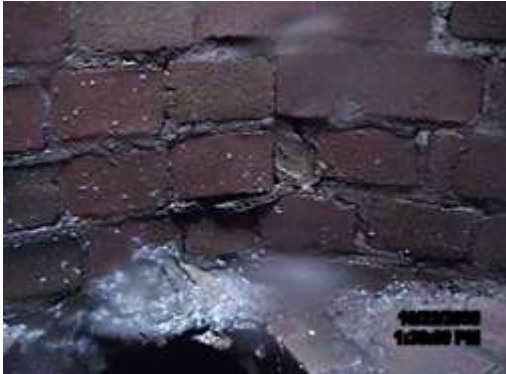
Defect

Infiltration: ☐ None ☐ Joint ☐ Cracks ☒ **Mortar** ☐ Roots ☐ Wall

Barrel infiltration.

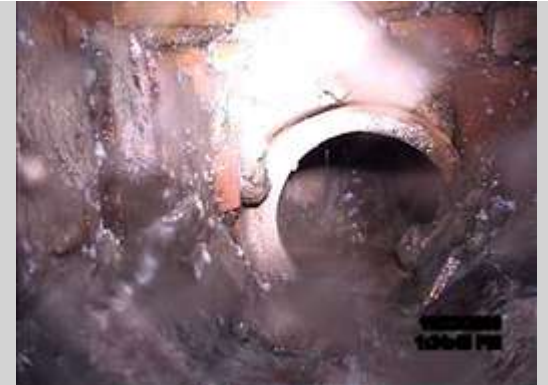
8 in. Circular Gravity Sewer Pipe Out @ 12 O'Clock

Invert Depth: **8.40** (ft.) Flow Characteristics: **Slow**

Infiltration: **None**

Pipe Seal Cond: **Sound**

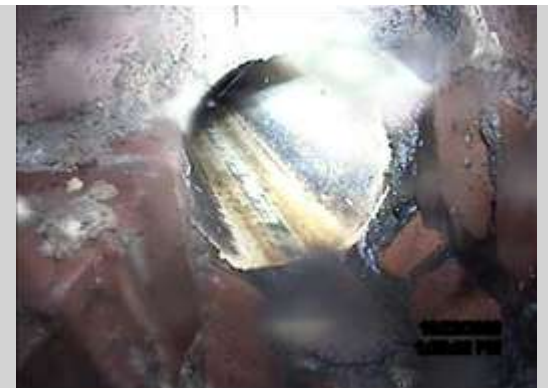
6 in. Circular Gravity Sewer Pipe In @ 3 O'Clock

Invert Depth: **8.00** (ft.) Flow Characteristics: **None**

Infiltration: **None**

Pipe Seal Cond: **Sound**

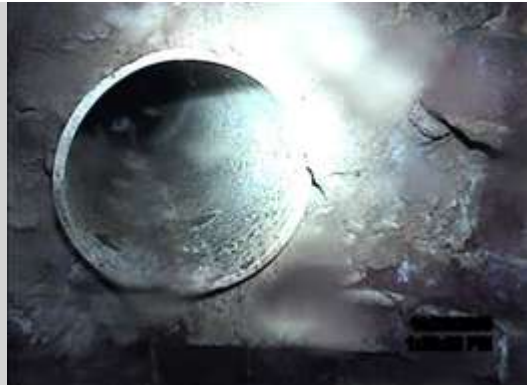
Pipe In @ 4 O'Clock

Invert Depth: **4.80** (ft.) Flow Characteristics: **Slow**

Infiltration: **None**

Pipe Seal Cond: **Sound**

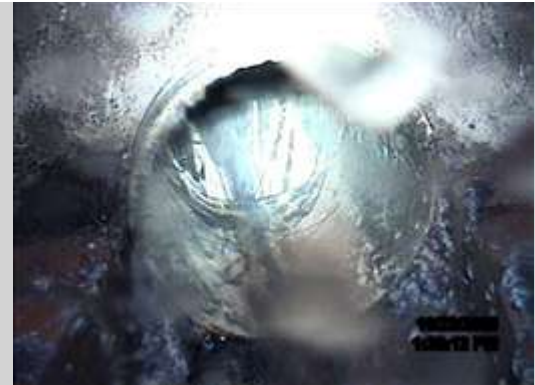
Drop In @ 4 O'Clock

Drop: **Outside** Rod and Bar

Angled: **Yes** Reading: **6.11** (ft.)

Inv Depth: **7.11** (ft.)

Drop Condition: **Open**

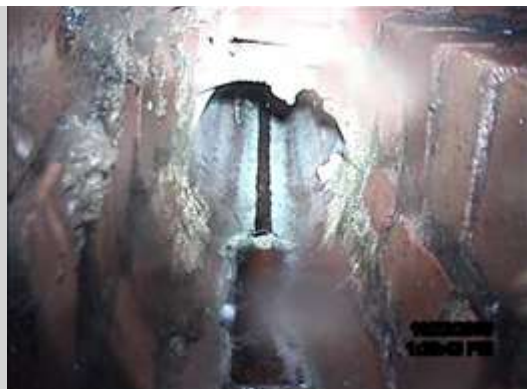
Pipe In @ 6 O'Clock

Invert Depth: **7.20** (ft.) Flow Characteristics: **None**

Infiltration: **None**

Pipe Seal Cond: **Sound**
